96-22

SPECIAL REPORT

# **Dredging in an Active Artillery Impact Area Eagle River Flats, Alaska**

Michael R. Walsh, Edwin J. Chamberlain, Karen S. Henry, September 1996  
Donald E. Garfield and Ed Sorenson

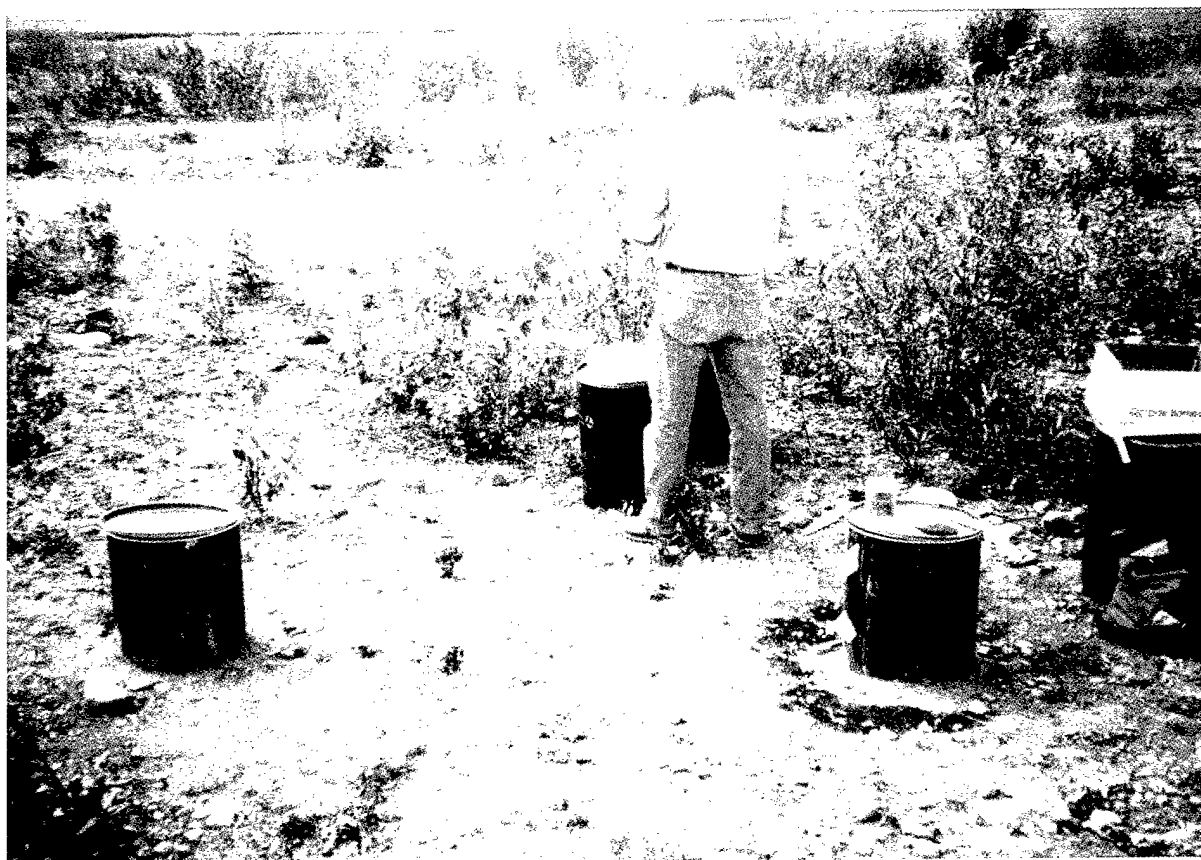
Figure 13. Hydraulic conductivity barrel test cells on the EOD pad.

a. Location of tests on the EOD pad.

*b. Test site.*

The site for the first series of tests was selected to be representative of the EOD pad. Modified barrels were used for the test chambers. The bottoms of 82.5-L steel barrels, 40 cm in diameter and 64 cm high, were removed and the barrels were set into the test pad as illustrated in Figure 14. The barrels were set into circular channels cut carefully into the pad to about a 15-cm depth. The annular space between the outer barrel walls and the gravel was backfilled with a wet mixture of sand and bentonite clay to prevent leaking of the water placed in the barrel for the infiltration tests. The interior annulus was refilled with a mixture of
